# CULTURAL RESOURCE SURVEY MAP FORM

CRS#	K-137	
------	-------	--

### CULTURAL RESOURCE SURVEY SURVEY UPDATE FORM

Jehu M. Reed House

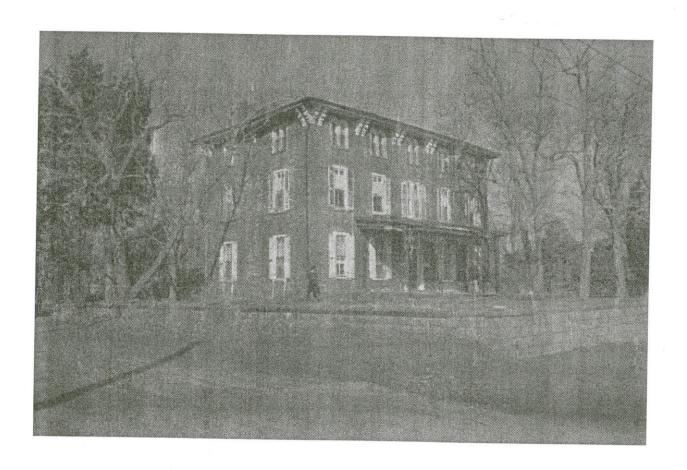
Figure 2: Jehu M. Reed House, view of south and east elevations looking northwest.

The front (or east) elevation of the main block is five bays wide, with the northern three bays being part of the original portion of the house. The northern three bays of the first two floors are in Flemish brick bond with glazed headers. The remainder of the front elevation is seven-course common brick bond. There is a one-story Victorian porch with decorative ironwork covering the central three bays of the front elevation. The central entry way is a recessed, double leaf door with a semi-circular fanlight. The windows on the first and second floors are narrow, two-over-two double-hung sashes, with paneled shutters on the first floor and louvered shutters on the second floor. The windows of the original Georgian building have segmental arches above. The windows on the third floor are paired, arched, one-over-one double-hung sash windows. There are paired, heavy brackets along the cornice. The roof is a low-pitched hip roof with two interior chimneys on both the north and south ends.

The south elevation is in seven-course common brick bond and is two bays wide, with two bays of the same two-over-two windows as on the front. The third story contains a date stone, "J.M.R 1868." There is an identical date stone on the third floor of the north elevation.

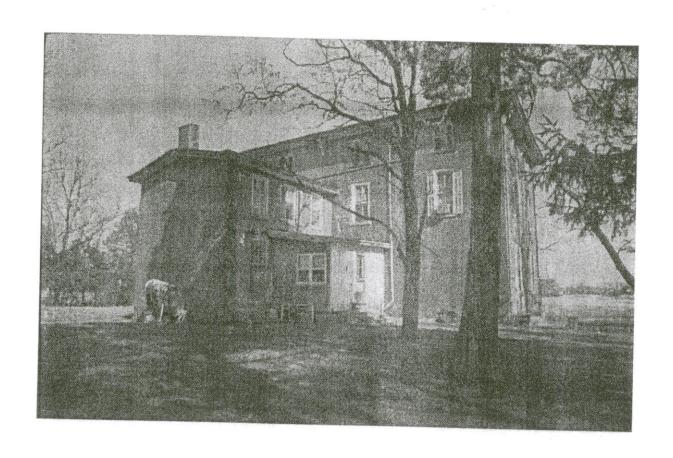
Figure 3: Jehu M. Reed House, view of west elevation looking northeast.

The rear (or west) elevation is seven-course common brick bond with a two-story addition projecting from the northwest corner of the main block and a one-story shed addition in the corner of the "L" which is formed by the main block and the two-story addition. The one-story addition is clad in plywood. There is a single leaf entrance on the south side of the shed addition and two nine-over-nine double-hung sash windows on the west side. The two-story

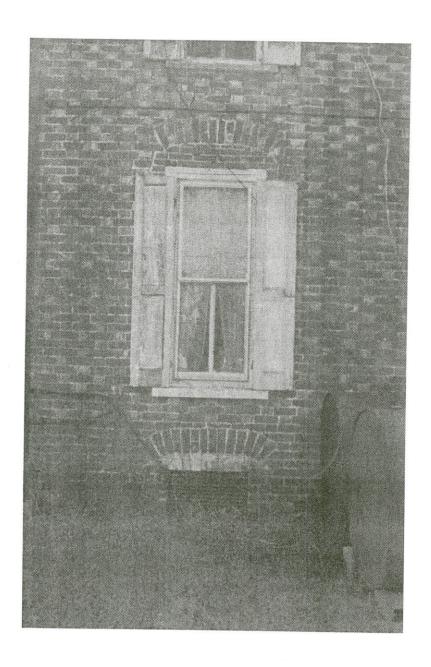
Figure 4: Jehu M. Reed House, detail of window on east elevation of Period I block.

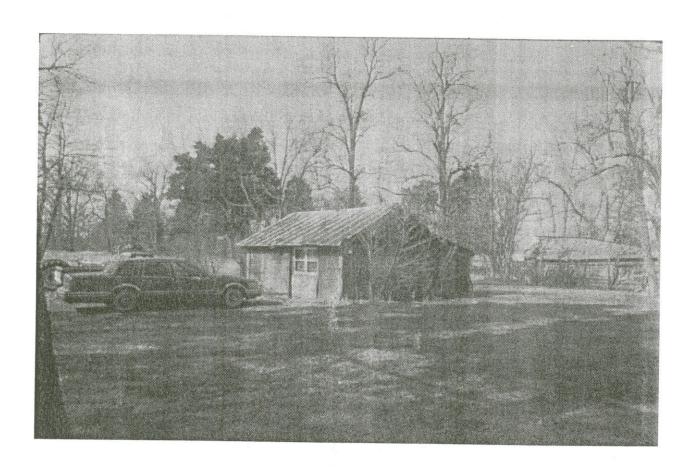
Figure 5: Jehu M. Reed Farm, view of east and south elevations of garage, looking northwest.

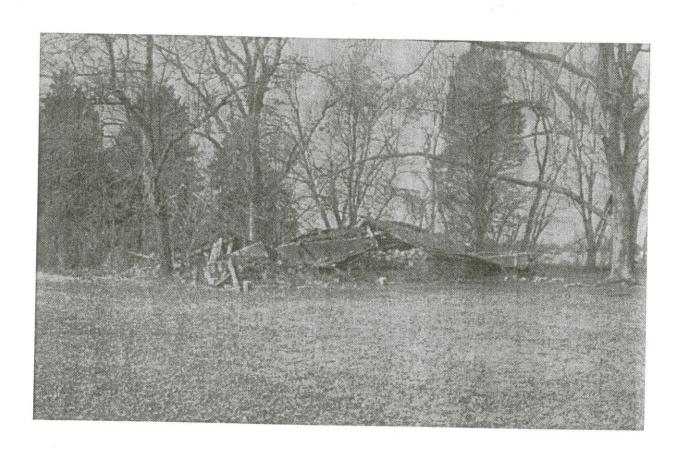
**Threat:** Although currently occupied, the Jehu M. Reed House is seriously deteriorated on both the exterior and interior. All of the outbuildings associated with the property, save for the garage, have either deteriorated or are in extremely poor condition.

Figure 7: Jehu M. Reed Farm, view of collapsed shed at northwest corner of property.

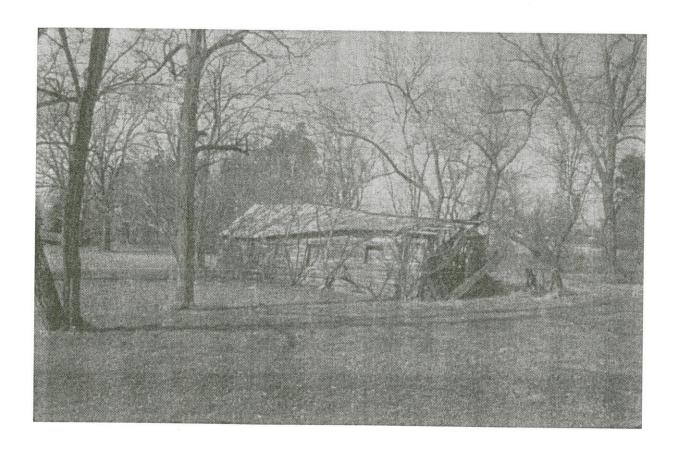
Figure 8: Jehu M. Reed Farm, view of north and east elevations of barn, looking southwest.
